Field Validation of a Drive-By Bridge Inspection System with Wireless BWIM + NDE Devices

Final Report

GDOT Research Project No. 14-30

FIELD VALIDATION OF A DRIVE-BY BRIDGE INSPECTION SYSTEM WITH WIRELESS BWIM + NDE DEVICES

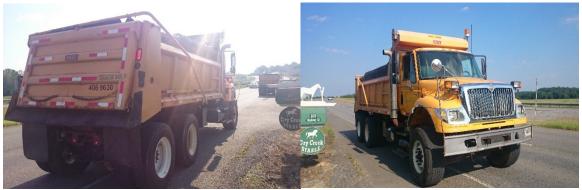
FIGURE 2-4 Half- and fully loaded vehicles

For bridge weight-in-motion analysis, a 3-D solid element was used to simulate the bridge using the LS-DYNA finite element program. To verify the model accuracy, two 3-axle trucks (one fully loaded and one half-loaded) were used (FIGURE 2-4).

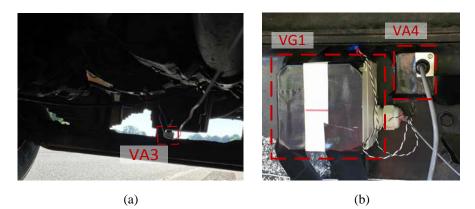
FIGURE 3-3 Installation of wireless sensors on the inspection vehicle: (a) accelerometer installed on the front axle; (b) accelerometer and gyroscope installed on the truck body
